Blackburn Skua (MkII) and Roc

A guide for panel lines, access panels and errors in published plans.

Issue 2F, Revised after inspection of FAA Museum Skua L2940. This revision Dec 2023

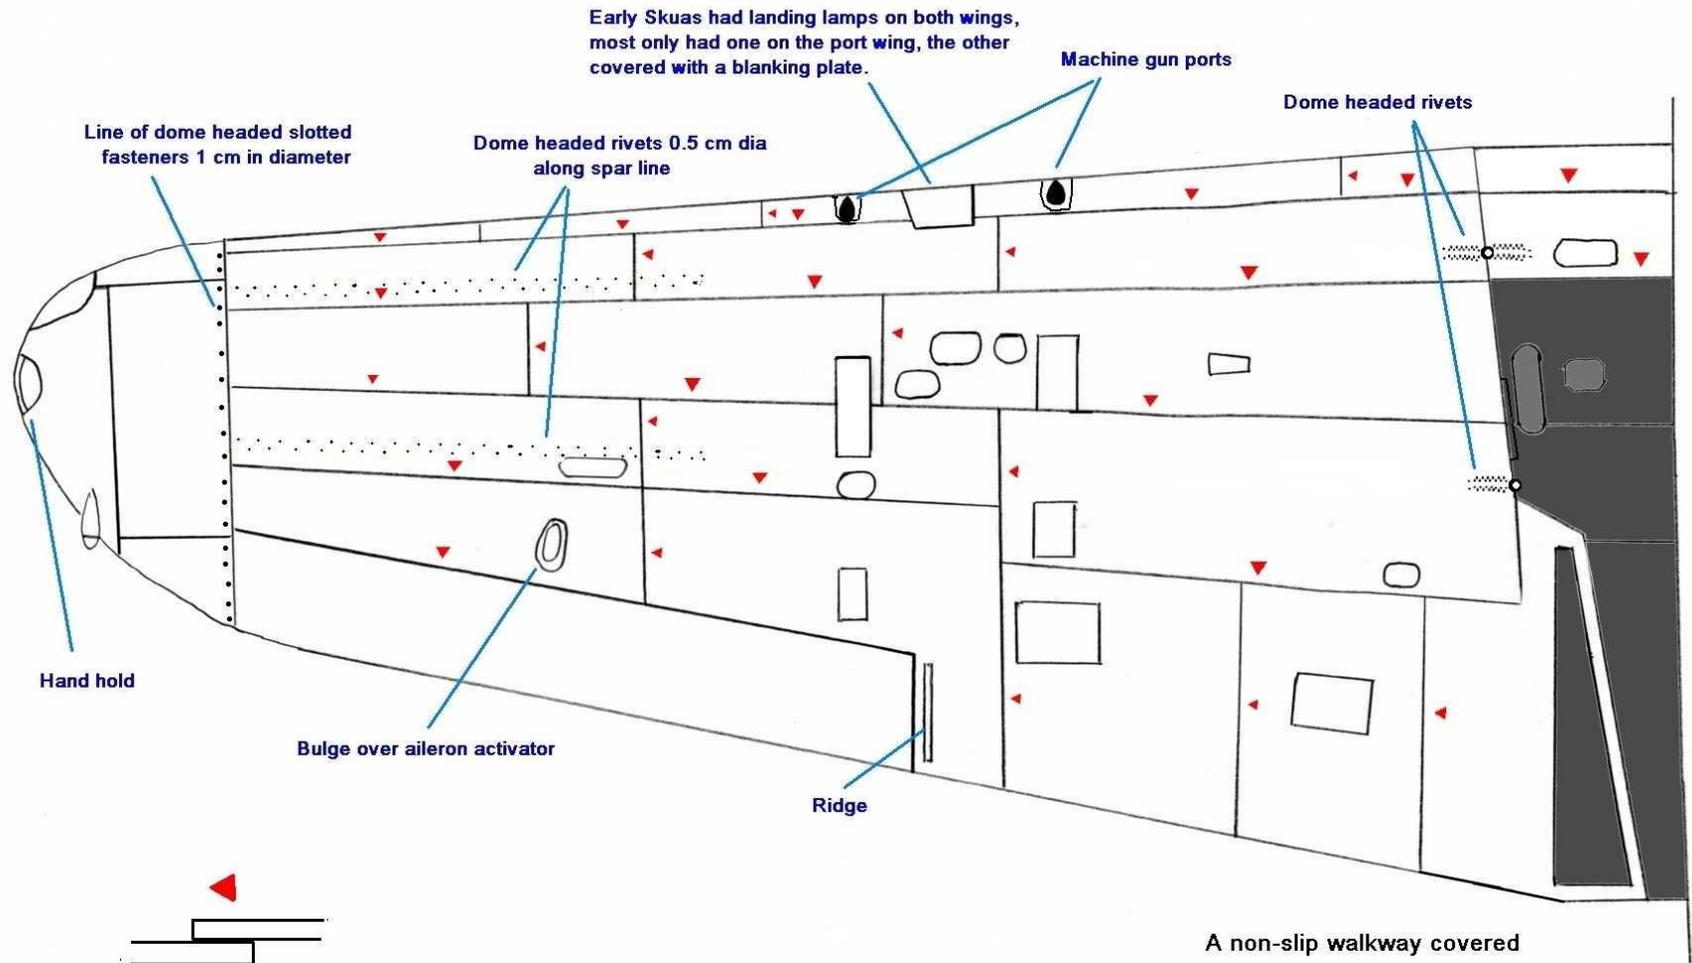
Blackburn Skua Top Wing.
Location of access ports.

Early Skuas had landing lamps on both wings, most only had one on the port wing, the other covered with a blanking plate.

Machine gun ports

Dome headed rivets

Line of dome headed slotted fasteners 1 cm in diameter

Dome headed rivets 0.5 cm dia along spar line

Hand hold

Bulge over aileron activator

Ridge

Red triangle shows direction of panel lap

A non-slip walkway covered panel joints and rivets. Note that on the 2nd prototype the walkway went to the leading edge of the wing.

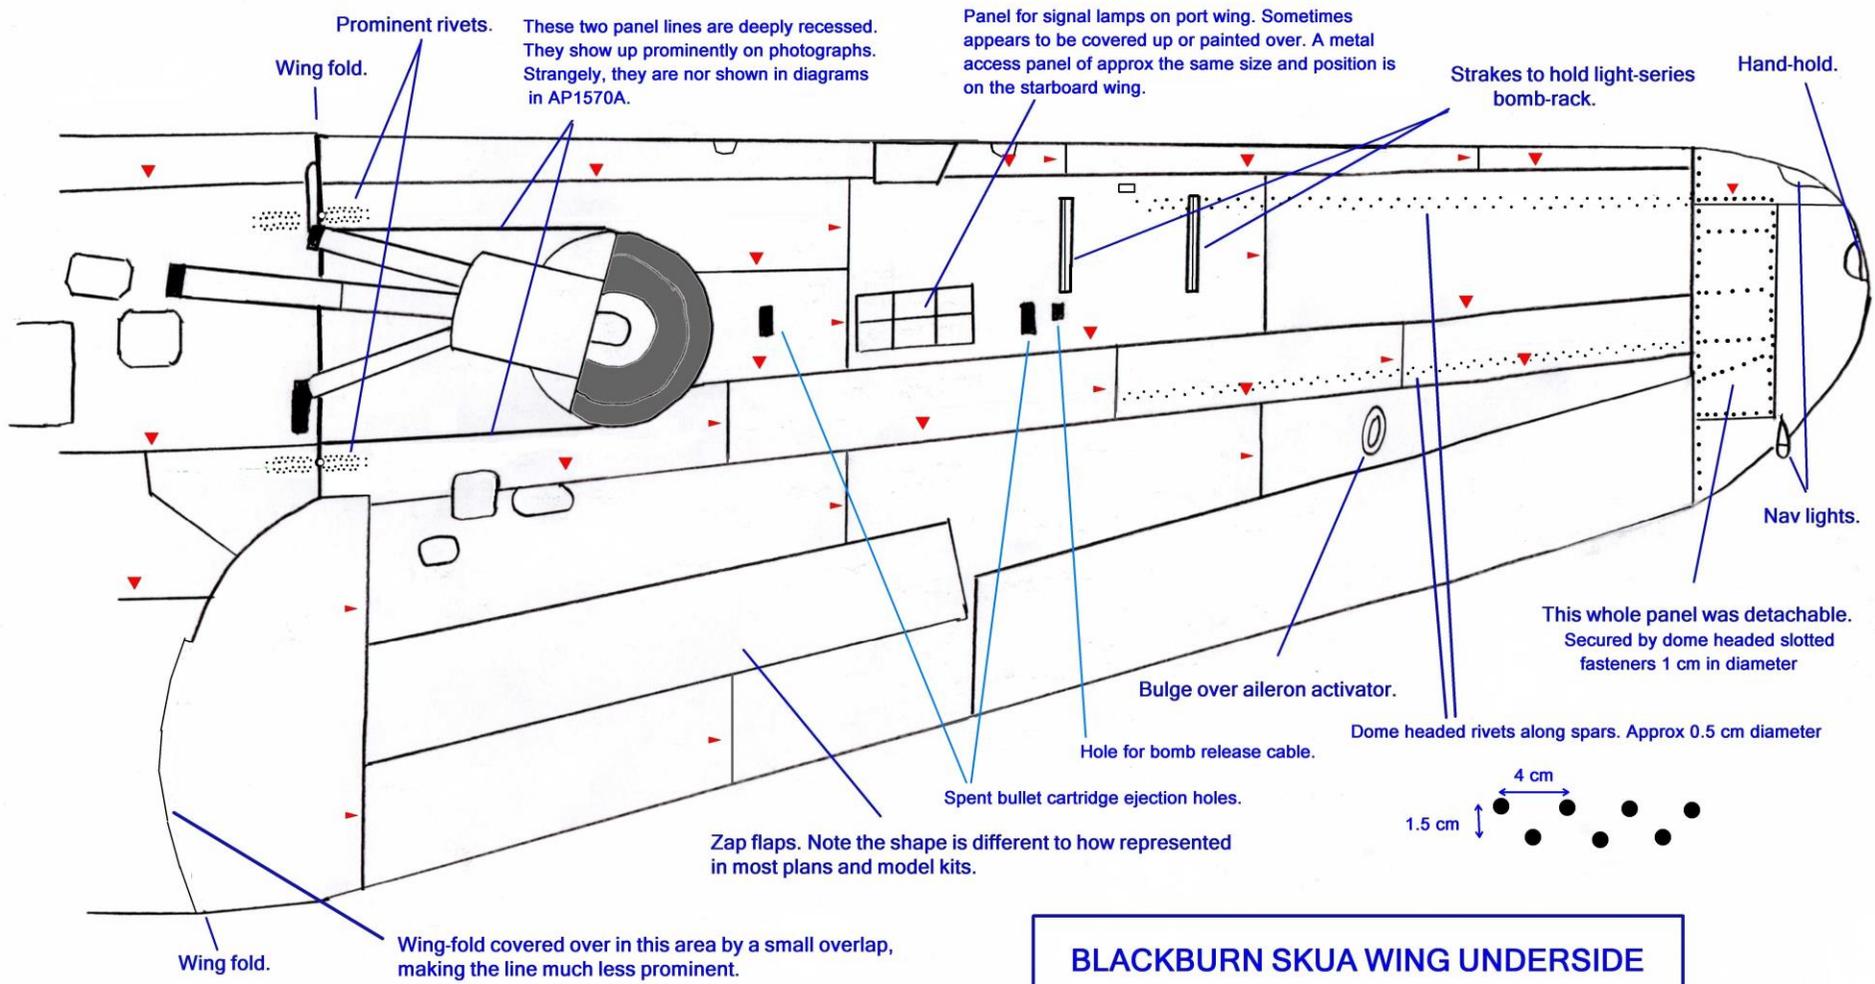
BLACKBURN SKUA WING UNDERSIDE
 Showing panel-lines, access panels and equipment.

The Skua used lapped joints. The red arrows indicate the direction of the lap.

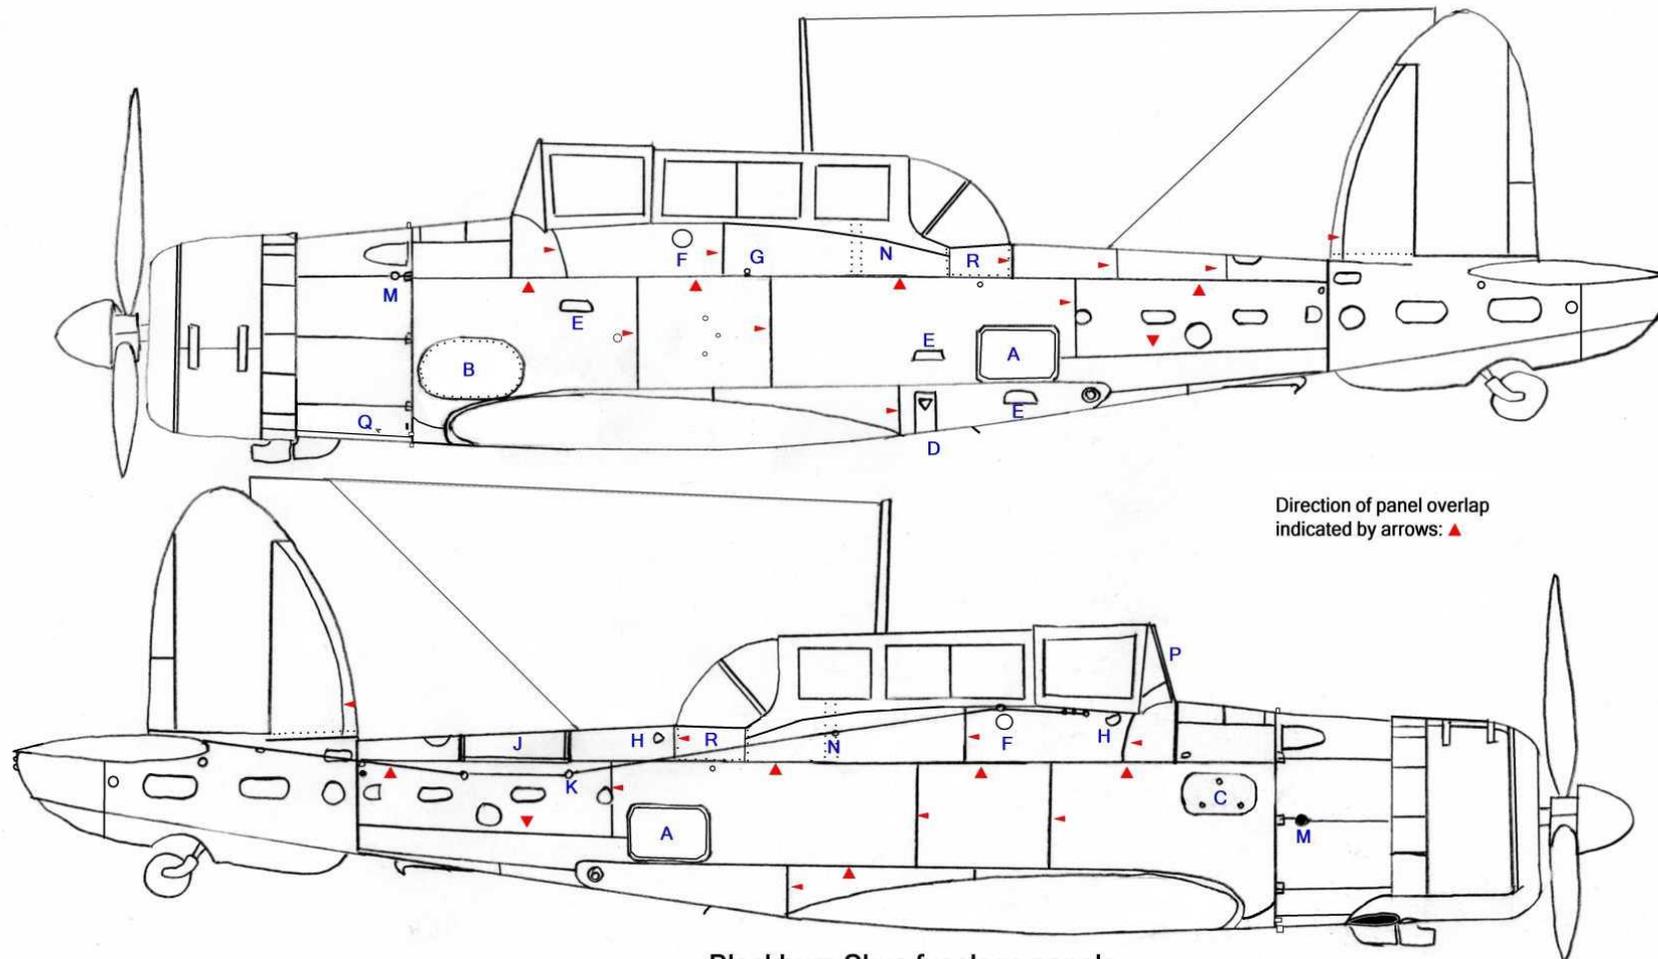
Blackburn Skua fuselage panels

Direction of panel overlap
indicated by arrows: ▲

A- Radio and first-aid access panels, both sides, raised rim around edge (see Willis Page 134)

B- Oval panel for front fuel tank, port side only. Approx 34 rivets around rim (see Willis page 45).

C- Oval inspection panel, starboard side only, with three prominent dome-headed fasteners.

D- Fold-down footstep.

E- Sprung foot/hand-rests, port side only.

F- Fuel cap covers for fuselage tanks, both sides.

G- Rod, approx. 10cm long, possibly retracts. Port side only.

H- Dinghy release handles (two), starboard side only.

J- Dinghy compartment.

K- Anti-stall parachute release & cut-free cables, starboard side.

M- Holes in front panels, not shown on most plans.

N- Rows of larger dome-headed rivets or bolts, both sides.

P- Armoured windscreen on some Skuas from Sept 1940.

Q- Small hose protrudes through hole in panel, port side only. See Willis page 115.

R- Removable sides of gunner's compartment, held in place by dome-headed fasteners.

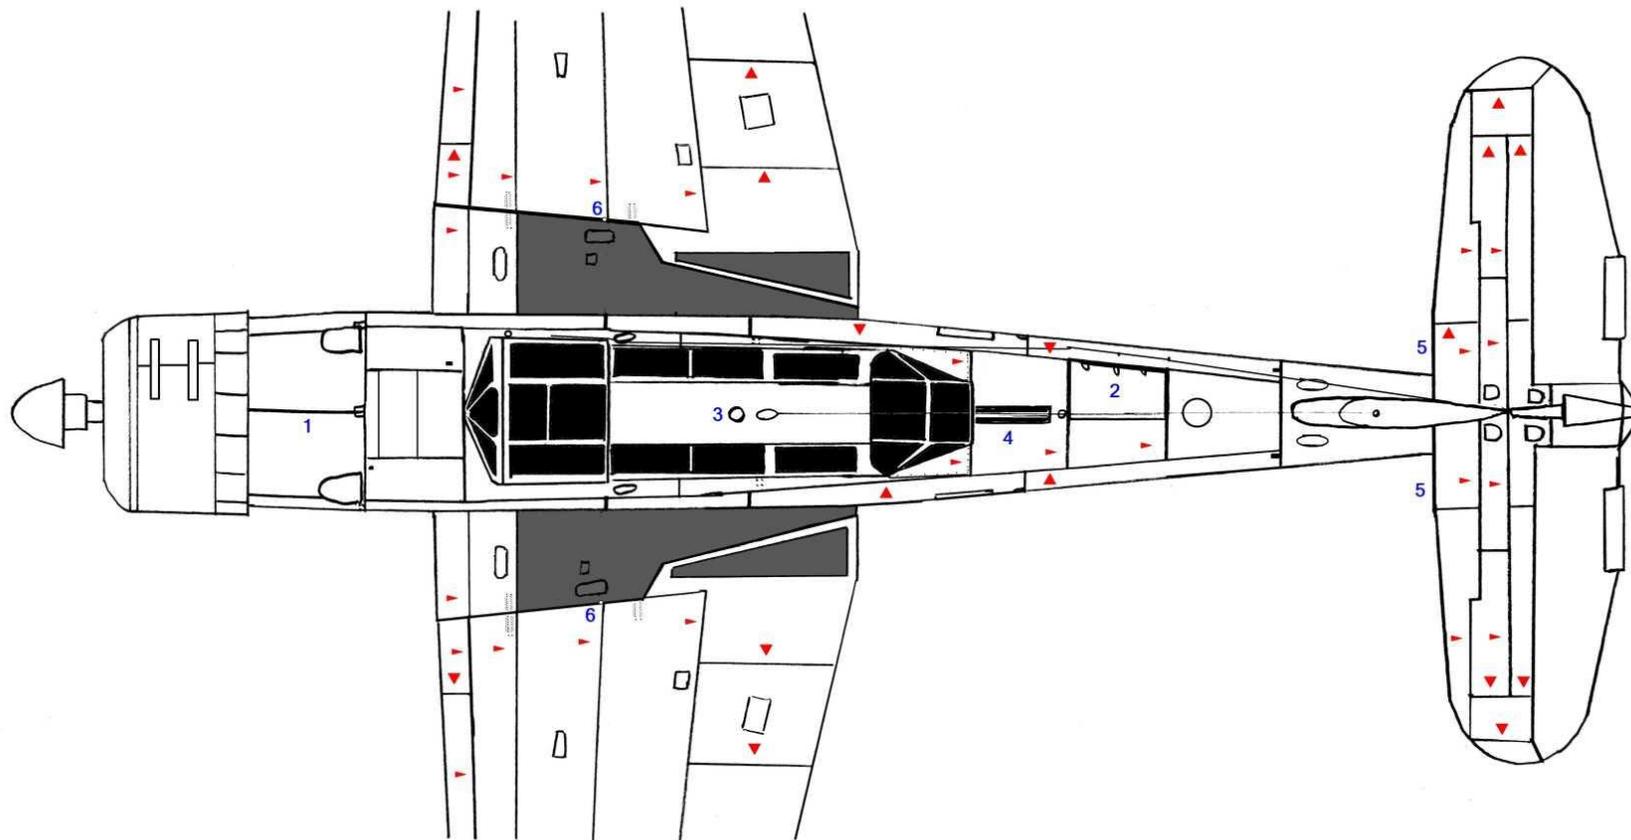
Blackburn Skua MkII fuselage top view

1. Panel-line along top of fuselage, missing from most plans.
2. Dinghy compartment, starboard side, extends very slightly to port side.
3. Top identification and signal lamp.
4. Gun recess trough, with wire aerial attachment insulator directly behind.
5. Straight edge to tailplane next to fuselage, shown wrong on most plans.
6. Undercarriage indicator rods, stick up 20-25 cm when undercarriage is up, bright-red in colour.

Red arrows show direction of panel "lap".

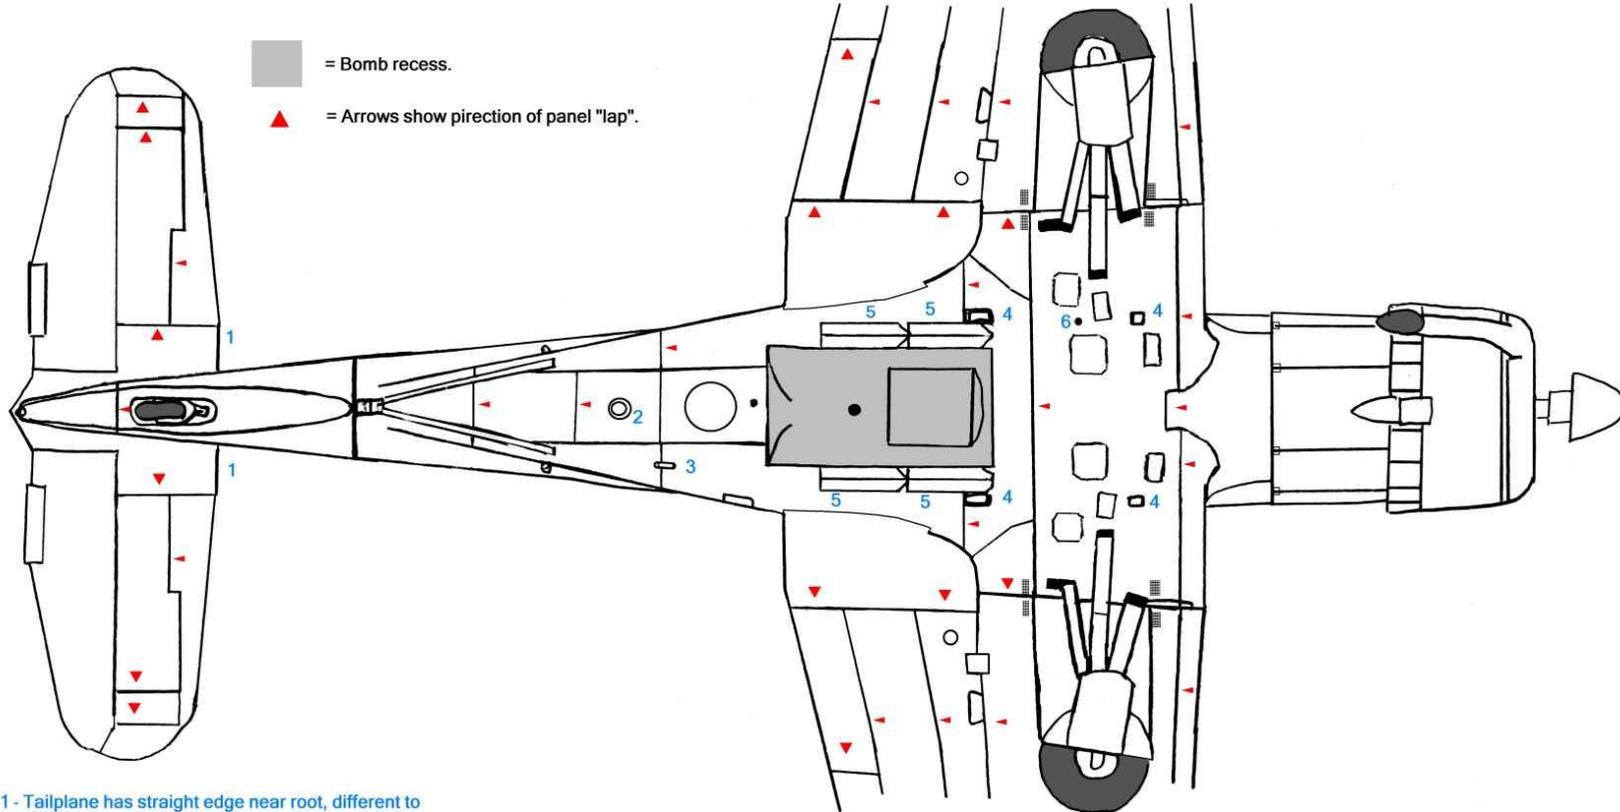
1 - Tailplane has straight edge near root, different to published plans.

2 - Downward signal / identification lamp.

3 - Tube for extending trailing wire aerial.

4 - Attachment spigots (four) for catapult launch trolley.

5 - Sprung doors for flares and smoke-floats.

6 - Signal pistol outlet.

There is some evidence that the bomb recess could be covered up by plates, when no bomb was carried. One photo (Willis page125) even suggests some sort of "bomb bay door". If any such equipment was available it seems to have been dropped from use once the war started.

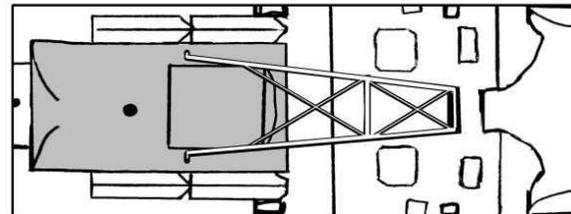
Bomb Recess with bomb crutch fitted.

14. There is some photographic evidence that, for a few months after the Skuas were first introduced into service, their bomb-recess would be covered up by a blanking panel (or panels) when no bomb was being carried (see Willis, Pages 14 and 125). This practice seems to have been dropped before the start of the war.

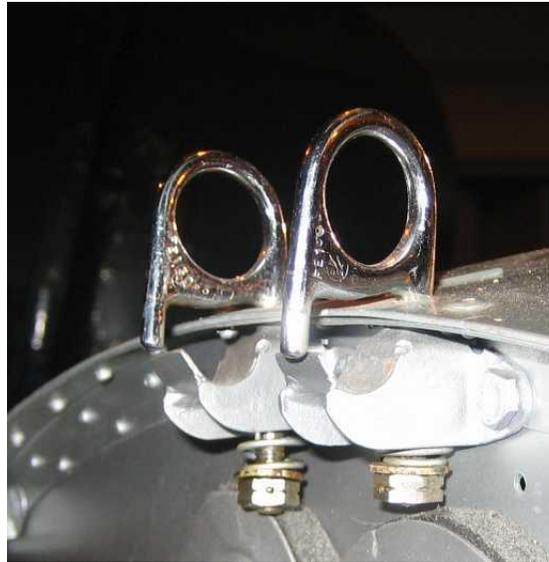
1. The two panels on either side of the fuselage to access the radio equipment had raised lips around their edge (Willis pg 134). A first-aid kit was also behind the panel on the starboard side, and stencilling often indicated that fact.
2. The oval front fuel tank panel cover on the port side of the fuselage had approx. 34 rivets/fasteners around its periphery.
3. The oval inspection panel on the starboard side of the nose had three prominent dome-headed fasteners.
4. The removable panels around the nose of the Skua were held in place by quick-release fasteners. These consisted of pairs of rings that stood out from the fuselage. You put your finger through the ring and pulled to release the panel (see photo below of the fasteners on the Bodo cockpit reconstruction).

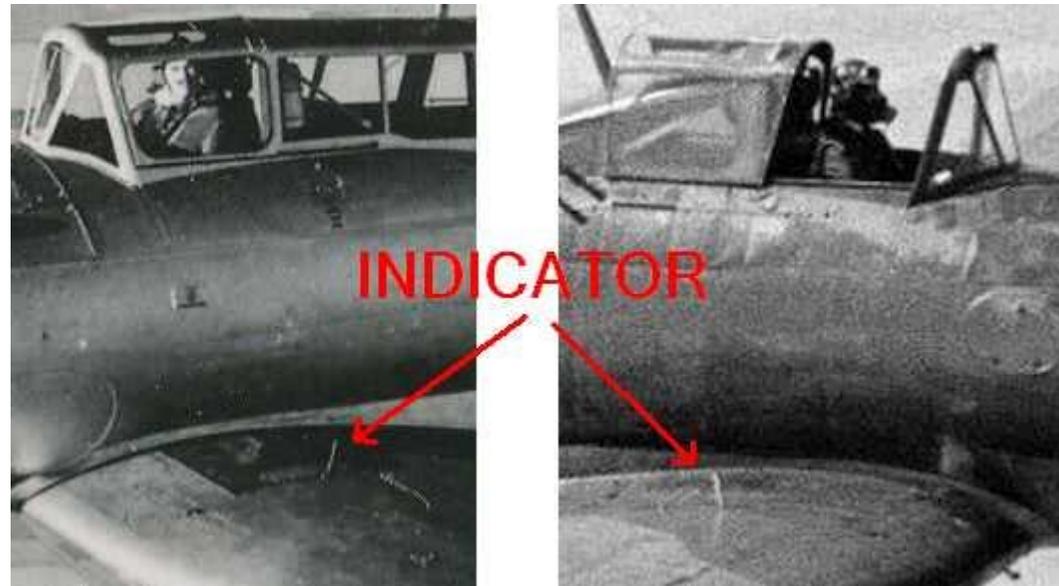
Location of the mechanical undercarriage indicator, left on Skua, right on a Roc.

18. If you are building a Skua or Roc in flight, be aware that a 20-25 cm bright-red painted flat-sided rod stuck up from both wings, on the line of the wing-fold. These indicated when the undercarriage wheels were retracted. This is the reverse of most other aircraft manufacturers, who made their mechanical indicators stick out when the undercarriage was extended. This did have the advantage that the rods would not be damaged by groundcrew bumping into them, but it must have added a bit to the drag of the Skua in flight. From examination of the wreck in the FAA museum it looks like the "rod" rotated back to lie flush with the top of the wing.

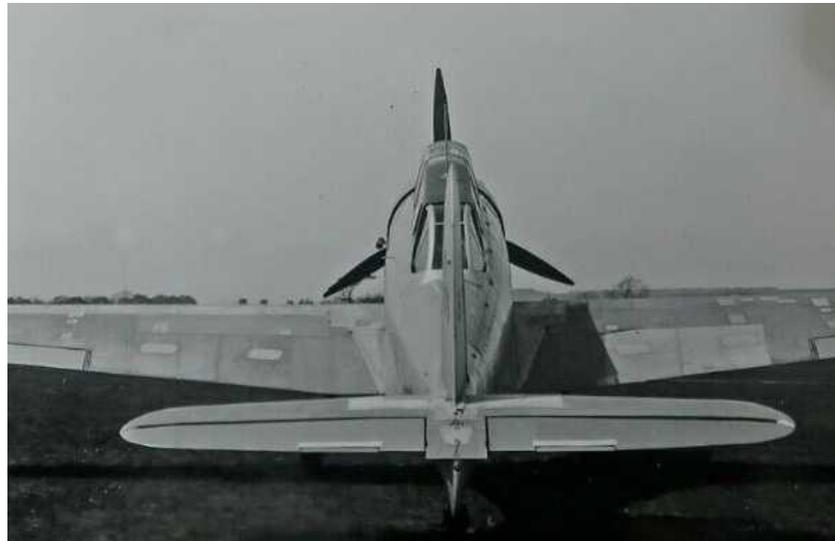
Where you can use your washes to pick out lines – (1) Wing fold line (but notice the “lip” that makes part of the line on the bottom of the wing less prominent). (2) The joint line between the tail unit and fuselage. (3) The removable covers around the nose. (4) The oval oil and fuel-tank cover. (5) The two lines next to the wheel-wells. These were exceptionally deep and wide (on the FAA museum example you can get your fingers well into them). (6) The flaps. (7) The rear fuselage hatches for access to the radio equipment. On a couple of photos of well-worn Skuas the panel line that curls up from the leading-edge wing-root to the removable nose panels stands out, presumably with oil and dirt blown back from the engine. On photos of cleaner Skuas it is not noticeable at all.

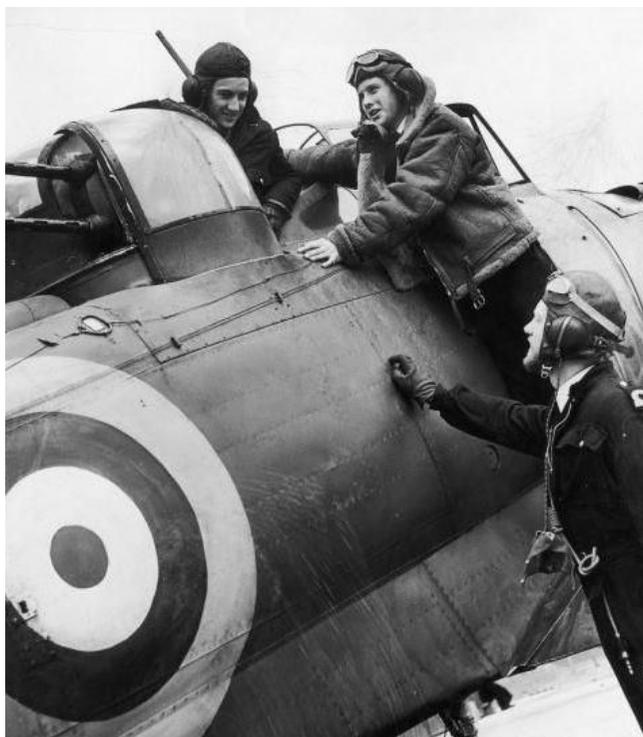
Starboard side of the Roc, notice the cable for the dingy release and one of its "ring-pull" handles, and below it the double cable-run for the anti-spin parachute in the tail.

11. The dinghy release cable was moved outside the fuselage (starboard side) and extended so that there was a third handle near the tailplane. This meant the Roc had three cables running down the starboard side: the dinghy release cable and the anti-stall parachute release and cut-free cables (these last two ran close together and look like one cable on most photos). From photographs it is clear that Rocs often flew with these cables removed. The dinghy was housed in the fairing on top of the fuselage.

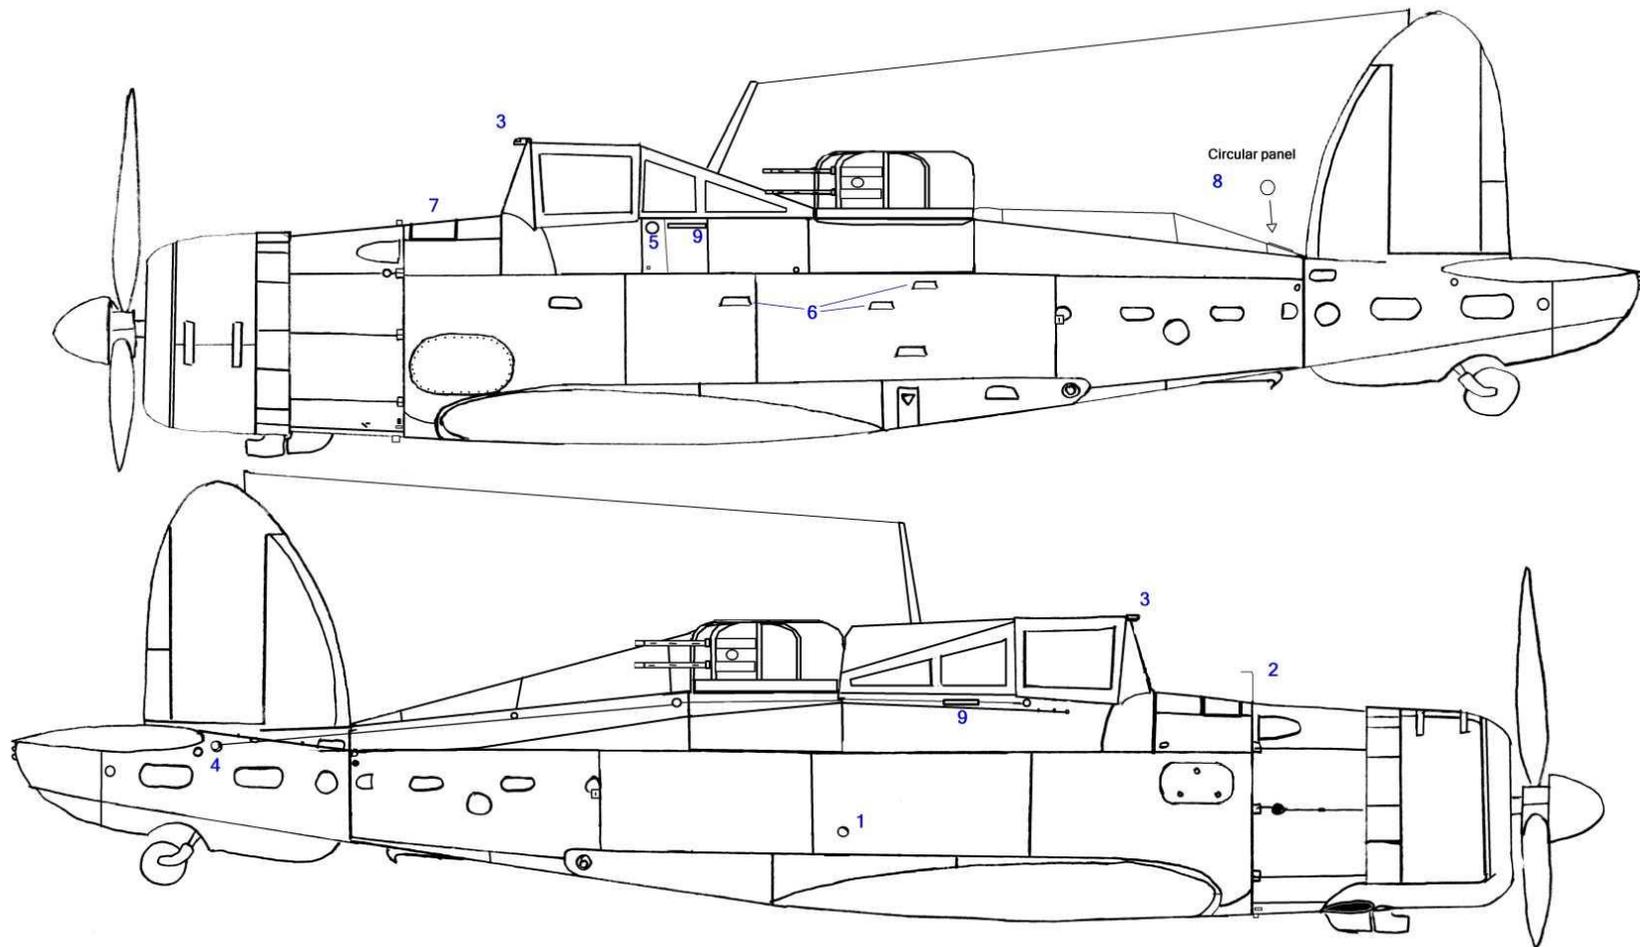
Blackburn Roc

1- Recessed circular socket, starboard side only, for connecting a "trolley acc" to power the turret on the ground for test or practice purposes.

2- Pipe, (de-icing spray?) seen in some Roc photos (see Willis, Page 37, 45 and 128).

3- Lamp in protrusion on top of windscreen. There was also a tiny "bubble" lamp on the fairing just in front of the turret, slightly offset to starboard (just visible in Willis page 30).

4- Extra handle for dinghy release on cable running external to fuselage, starboard side only. Dinghy was housed in the fairing on top of the fuselage.

5-Fuel filler cap, behind door, port side only. Circular panel on door could be left off to give quicker access..

6-Extra hand/foot rests for access to turret, port side only.

7-More pronounced panel lines (or outline marking?) than on Skua.

8- Circular panel on top of fairing to give access to CO2 cylinder for inflating the dinghy.

9- Ridge on both sides of fuselage, may indicate extra access doors to get at internal equipment.

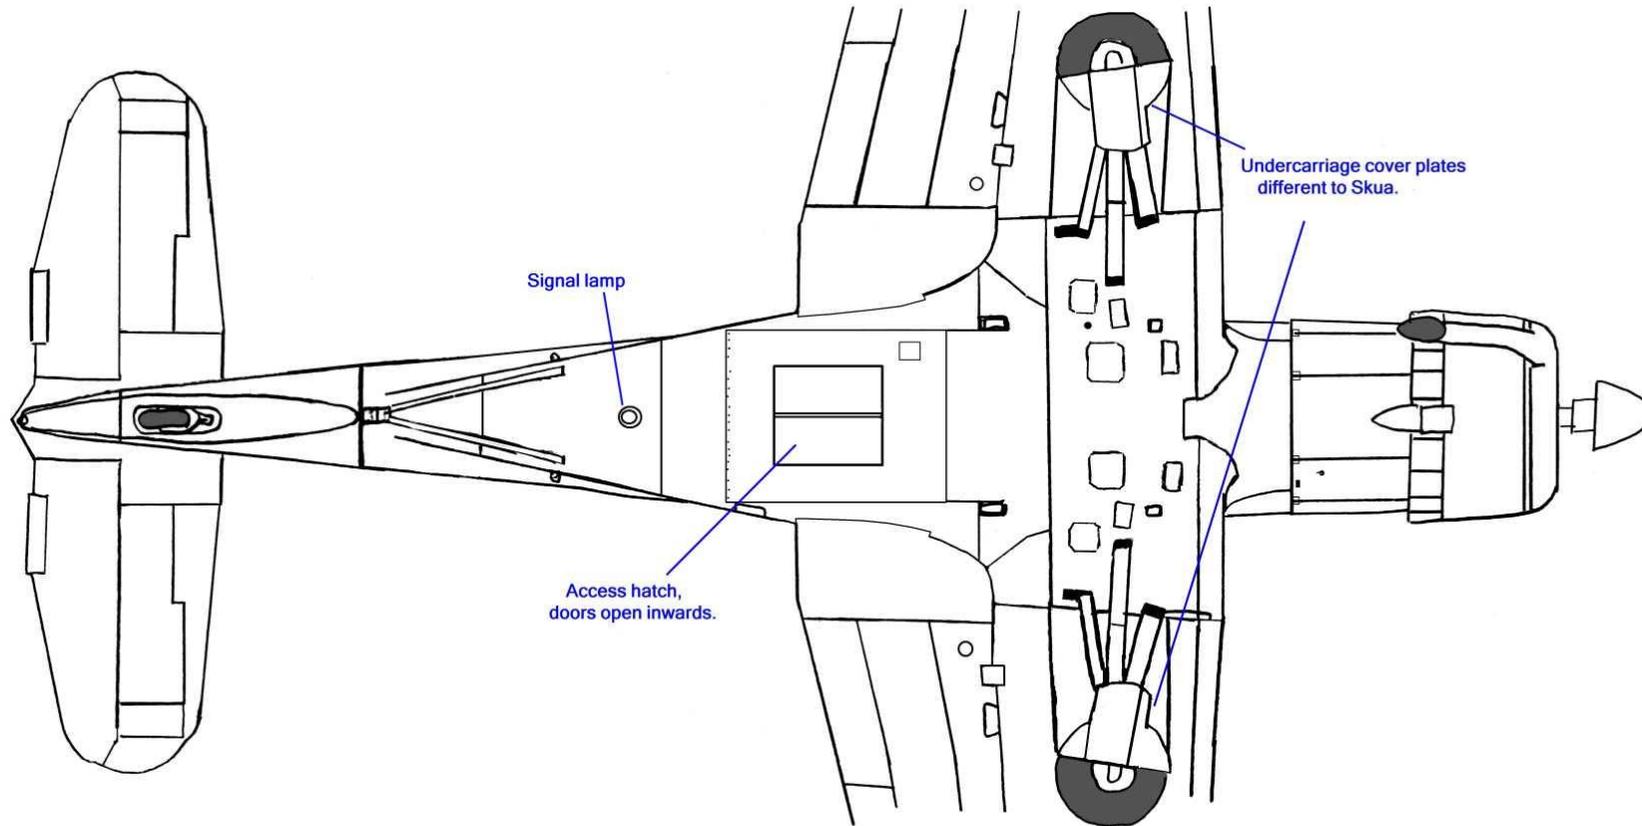
Blackburn Roc

The Roc had a flat area between the fuselage and the wing fillets (unlike the Skua which had a curved underside to the fuselage which mated with the fillets in a complex shape). There was door in the bottom of the fuselage for access to the inside for maintenance. This door was also available to the gunner as an escape route, but he usually got into the turret via the sliding doors at the rear of the turret. The Royal Navy did not issue Roc gunners with the all-in-one slimline "Rhino" parasuit used by RAF Defiant gunners. Instead, the parachute was stowed in either a receptacle built into the turret itself (near the gunners knees) or on the inside of the fuselage. The parachute would be clipped onto the front of the gunner's harness before jumping .

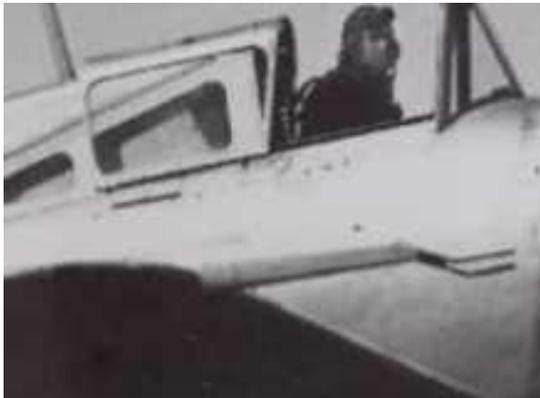
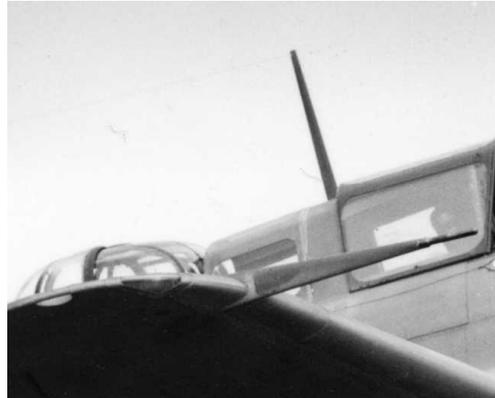
The two styles of pitot tube seen on both Skuas and Rocs, in this case on Rocs. To the left is the early two-pronged type, generally seen on pre-war photos of “silver” Skuas and Rocs. On the right is the later simpler type seen on most wartime photos. The earliest serial number Skua I can find with the later type is L2923, a late aircraft of the first batch of Skuas ordered. The last Roc serial number I can find with the earlier pitot type is L3090, about one third of the way through the Roc production run.

Pitot tube – The pitot tube was mounted on the starboard wing. It was on the wing-tip section, approx 8 cm outboard of where the tips bent up on the Skua and in the same position on the Roc (although the Roc did not have upturned wing tips). In early pre-war photos of Skuas and Rocs the pitot tube has two distinct tubes, one above the other and the tubes bend up to mate with a thicker section. On later photos of both Skuas and Rocs there is just a single tube that is in line with the thicker section.

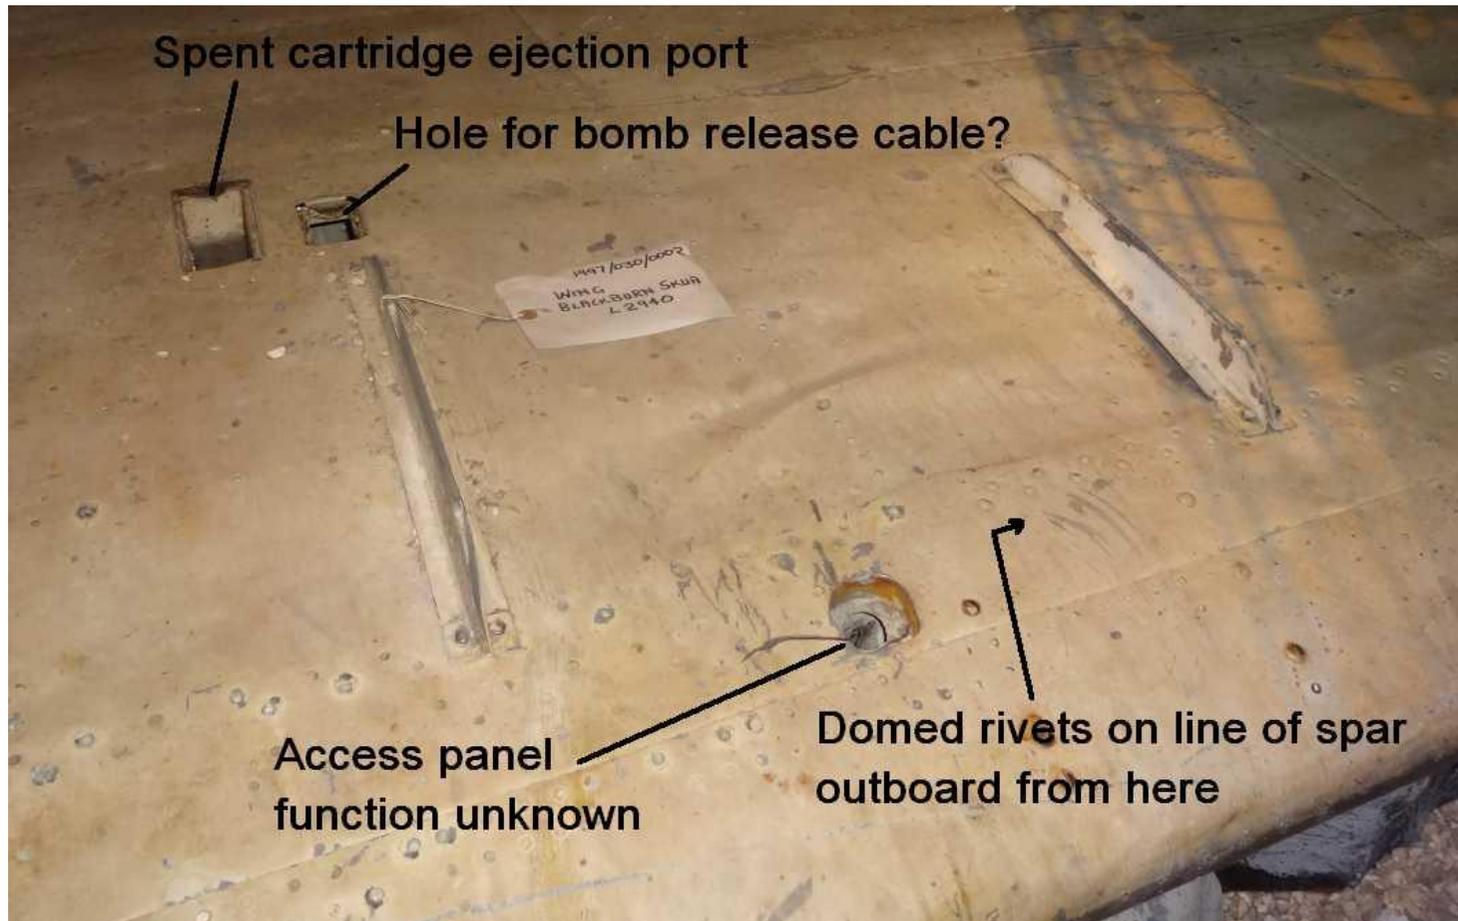
Photo1: The strakes on the underside of the starboard wing for attachment of a light series bomb rack.

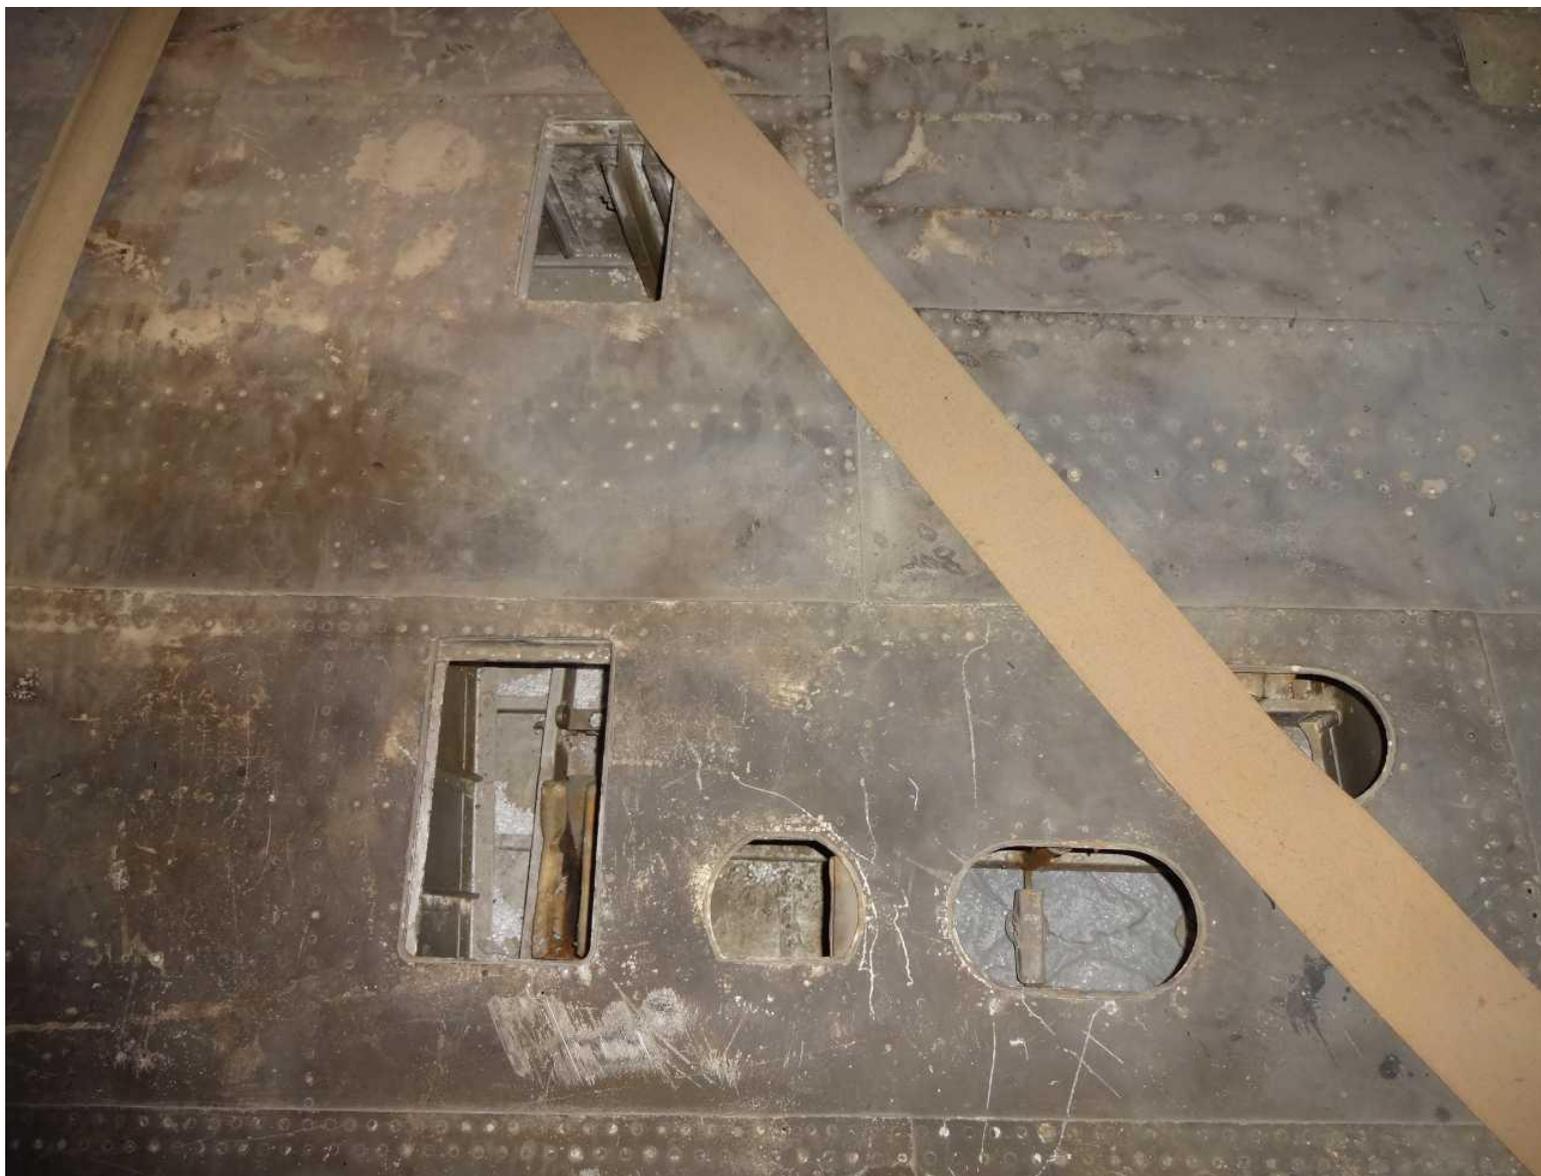
Photo 2: Open panels on top of port wing.

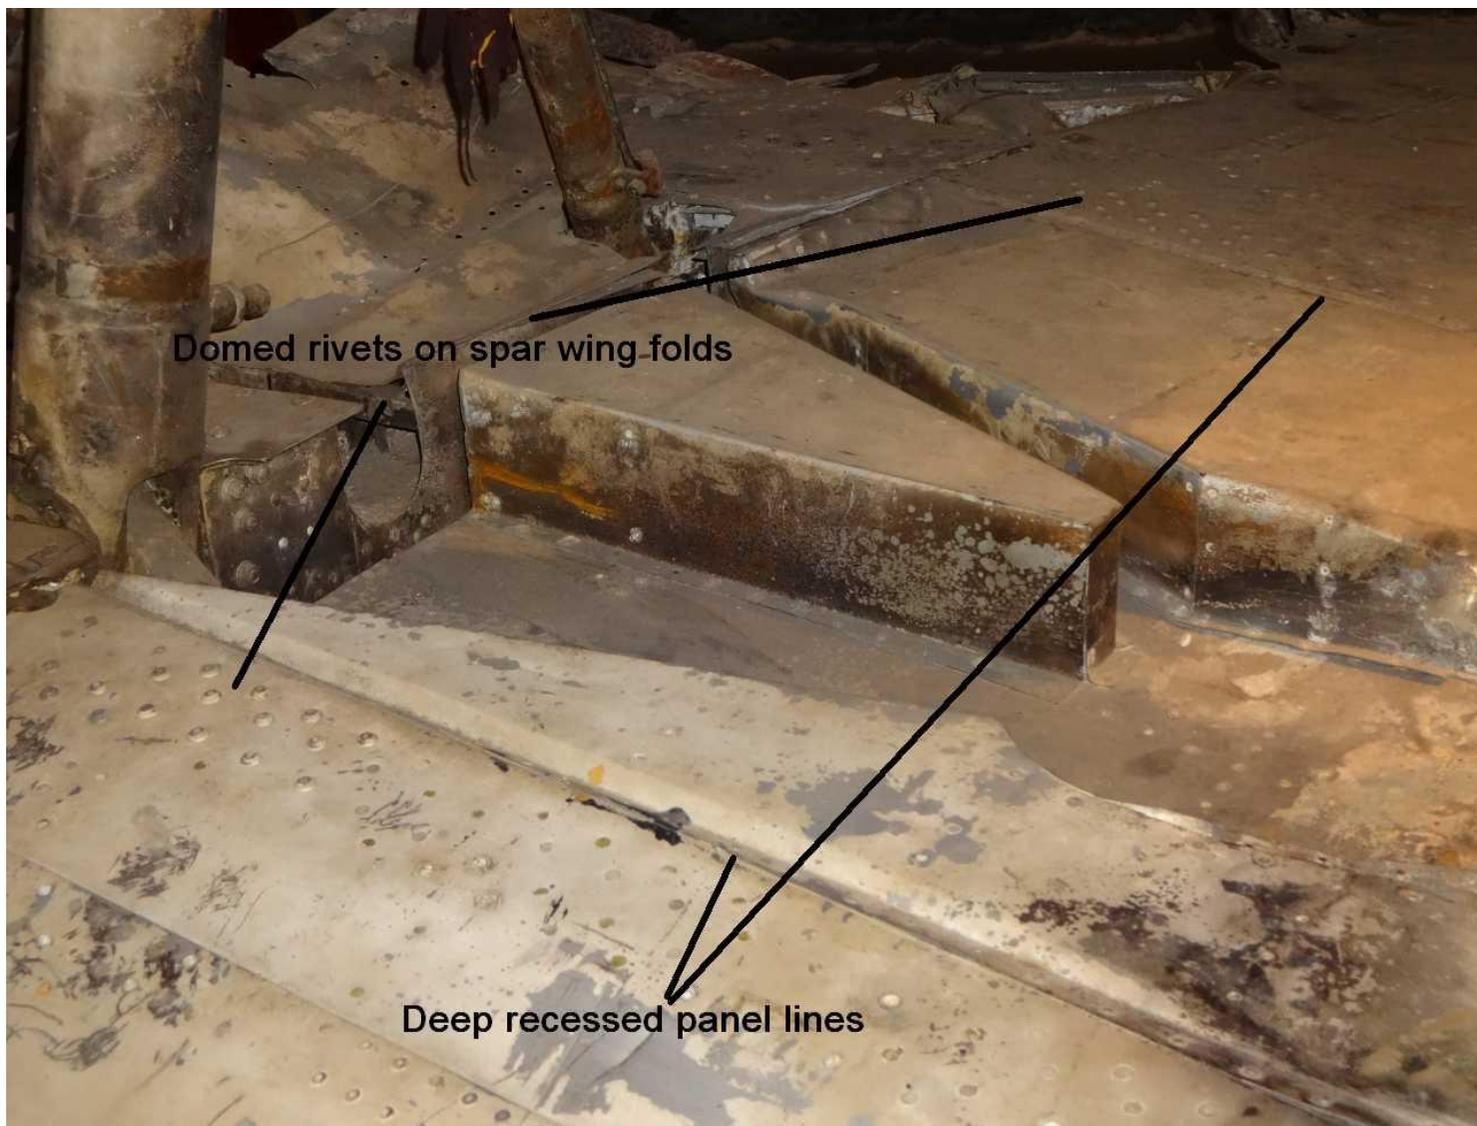
Photo 3: Undercarriage leg recess, starboard wing.

The panel lines on the wings in this diagram from AP1570A match up exactly with those observed on photos of Blackburn Skuas and on the wrecked Skua in the FAA Museum except in one crucial place. There are two deeply recessed panel lines running from the outer diameter of the wheel recess to the wing fold line (see photo 3). Just why AP1570 appears inaccurate in this area is unclear.

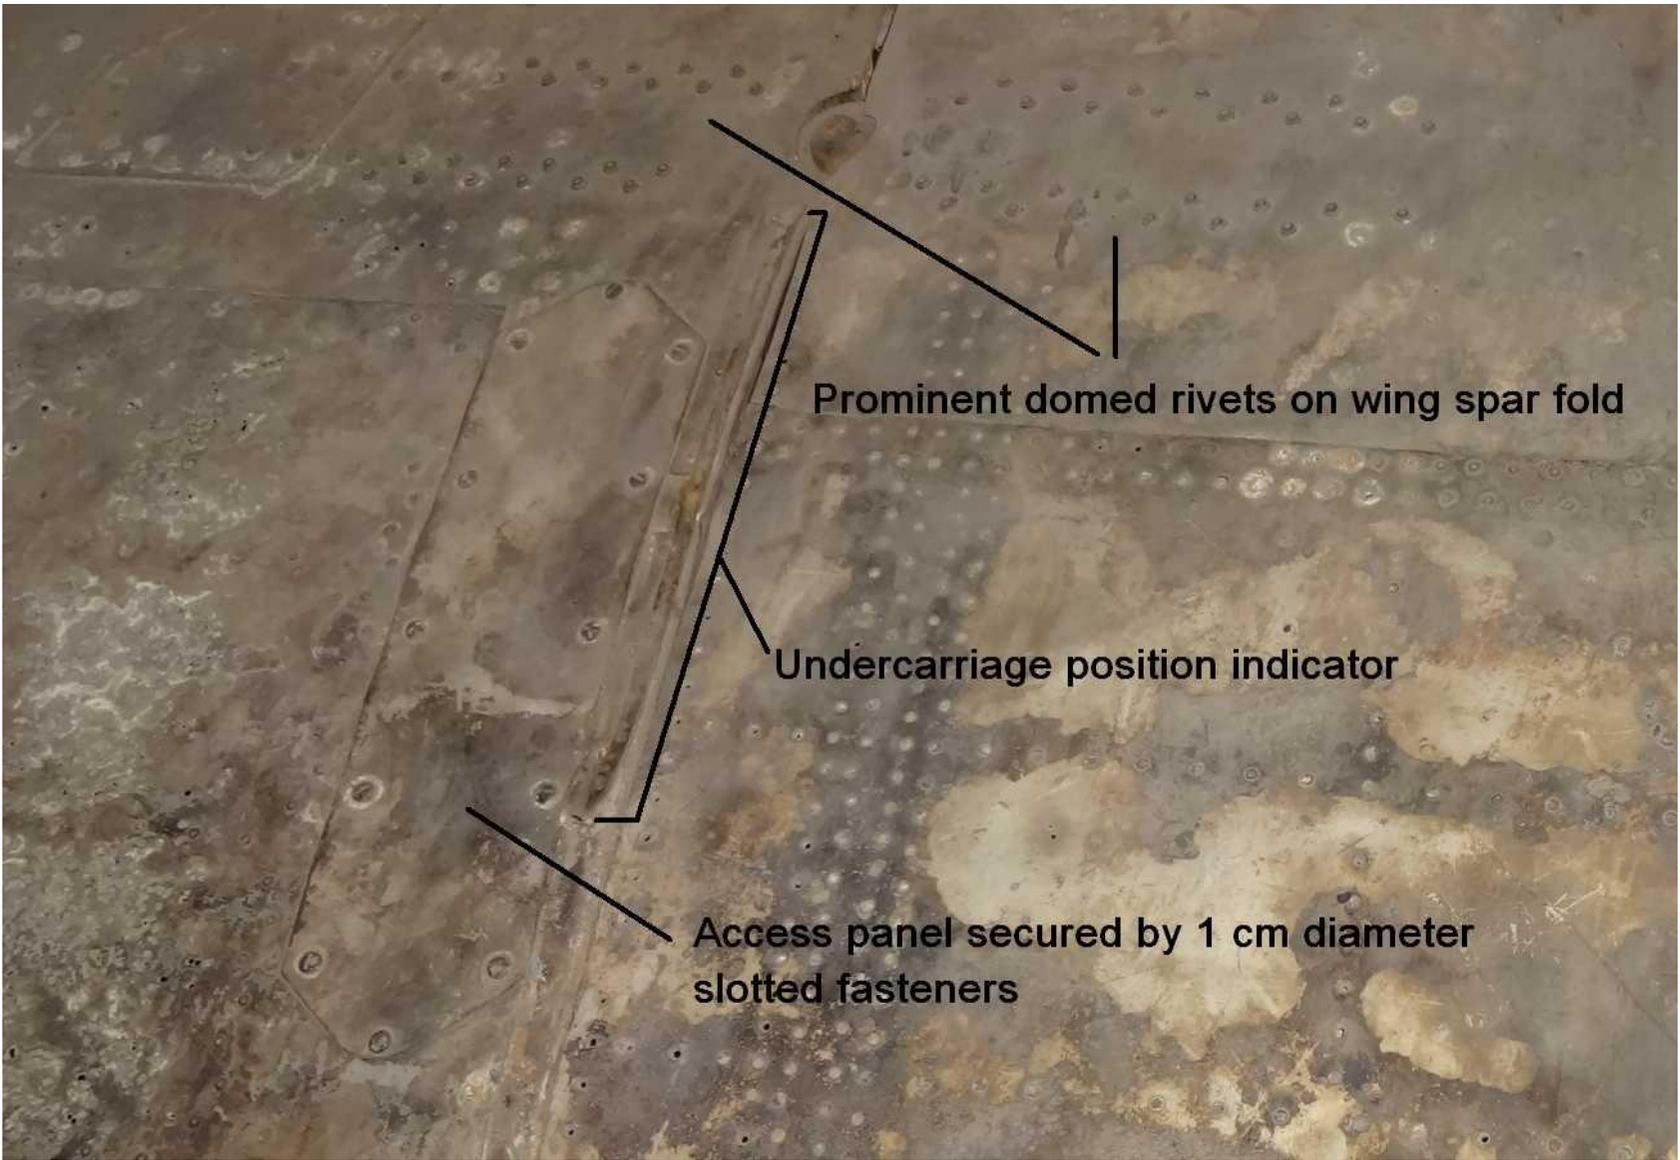
Photo 4: Top of port wing, showing area around the wing-fold. Outboard is to right of picture. Area to right would have been covered by rubber walkway.
