Blackburn Skua (MkII) and Roc

A guide for panel lines, access panels and errors in published plans.

Issue 2F, Revised after inspection of FAA Museum Skua L2940. This revision Dec 2023

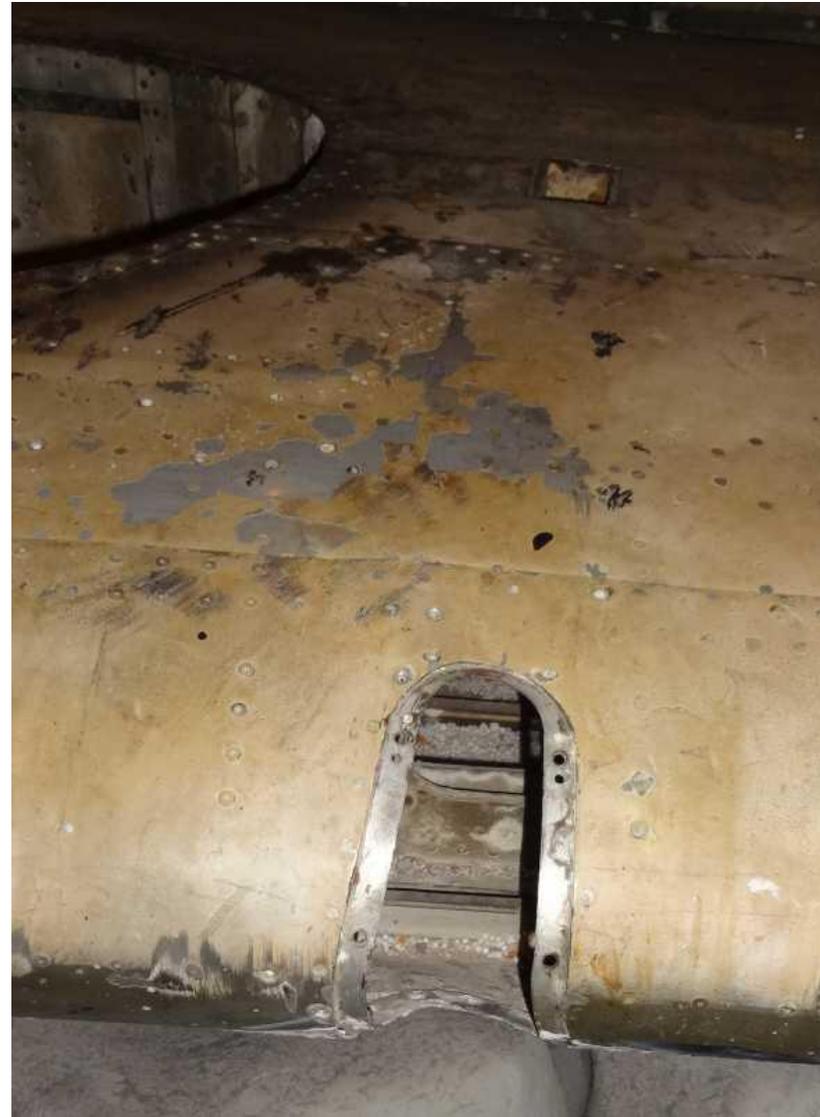
Photo 5: Machine gun opening in wing leading edge, looking from bottom of wing. This area was covered by a plate with only a small hole on the top of the leading edge for the gun to fire through. Presumably this larger opening was required when fitting or removing the gun so it could be angled up through the relatively small access port on top of the wing.

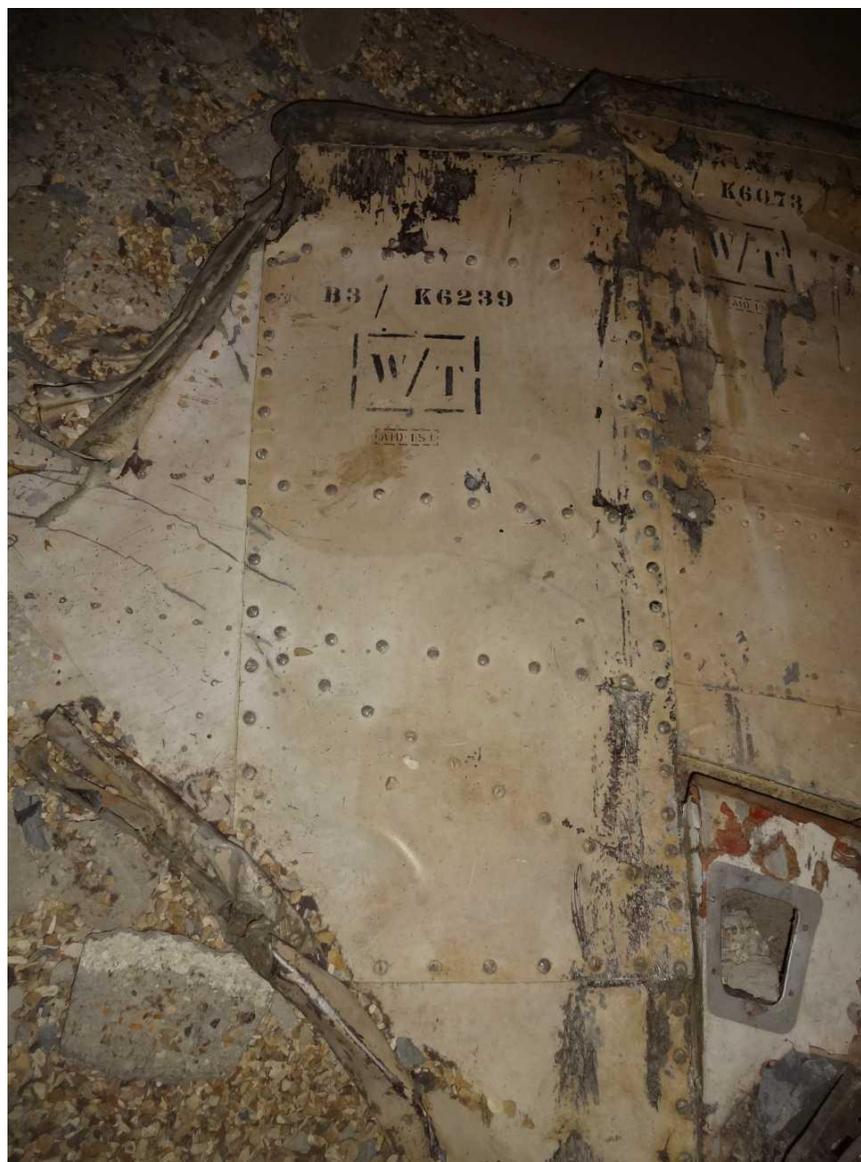
Photo 6: The removable panel on the underside of the wing tips was held in place by lots of domed, 1 cm diameter slotted fasteners. It must have taken ages to remove it.

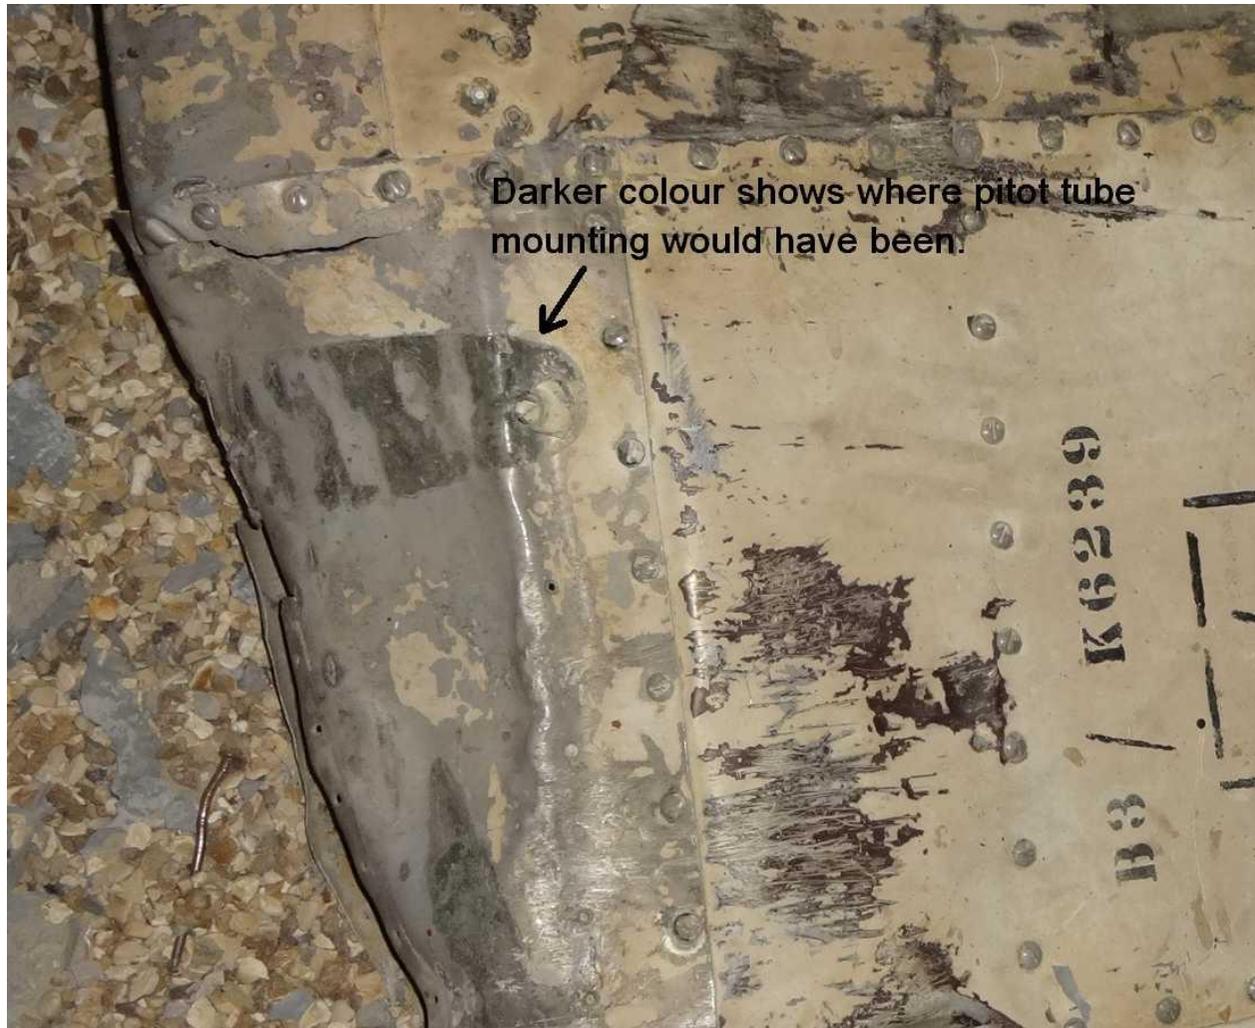
This discolouration on the leading edge of the starboard wingtip shows where the pitot tube would have been mounted. The middle being 8 cm outboard of where the wing tips tilt upwards. The mounting would have extended further back on top of the wing.

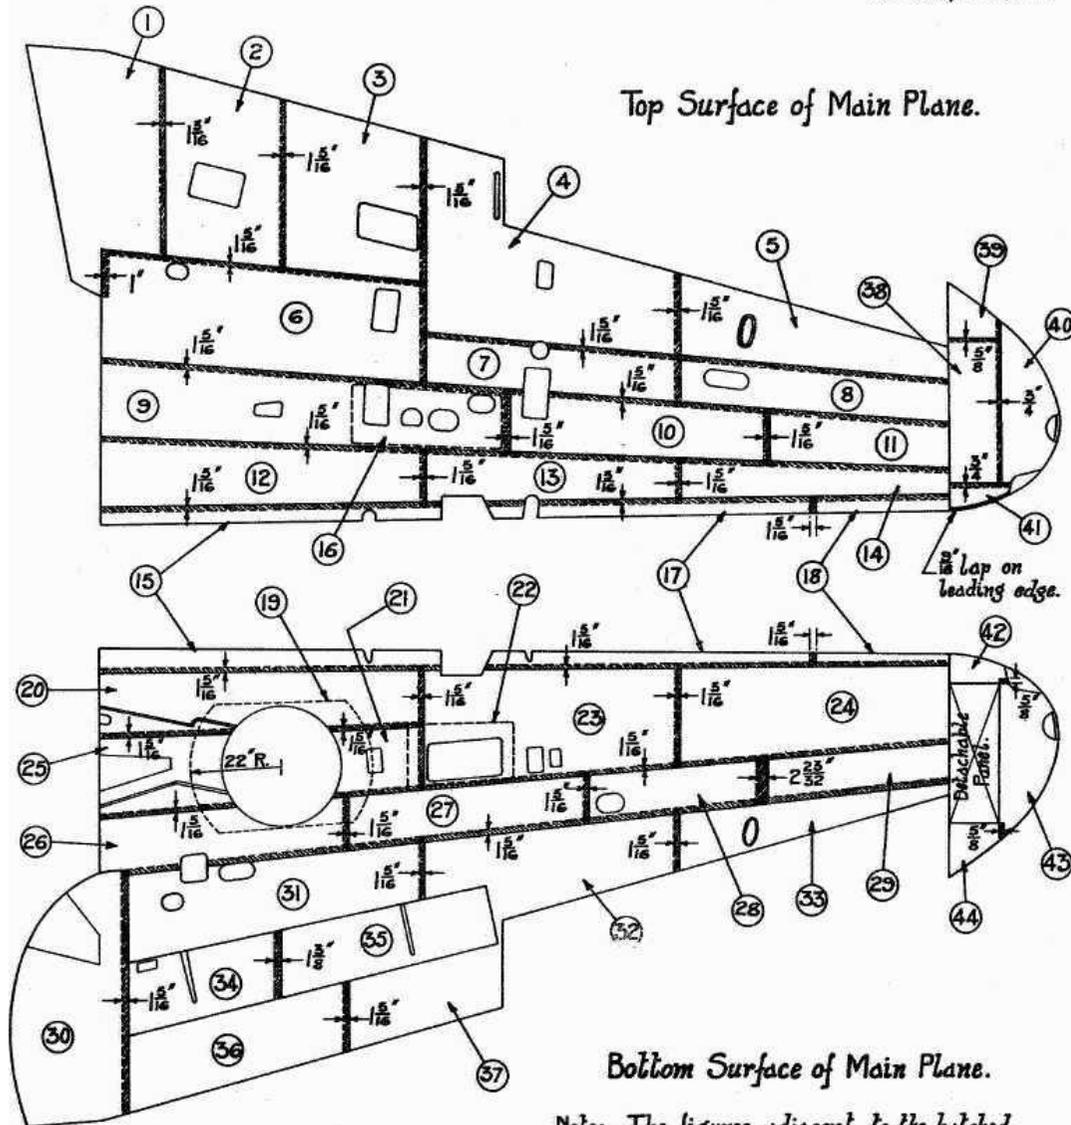
A.P.1570A, VOL. II, P.13

Note:- The figures adjacent to the hatched portion show the width of lap required.

The panel lines on the wings in this diagram from AP1570A match up exactly with those observed on photos of Blackburn Skuas and on the wrecked Skua in the FAA Museum except in one crucial place. There are two deeply recessed panel lines running from the outer diameter of the wheel recess to the wing fold line (see photo 3). Just why AP1570 appears inaccurate in this area is unclear.

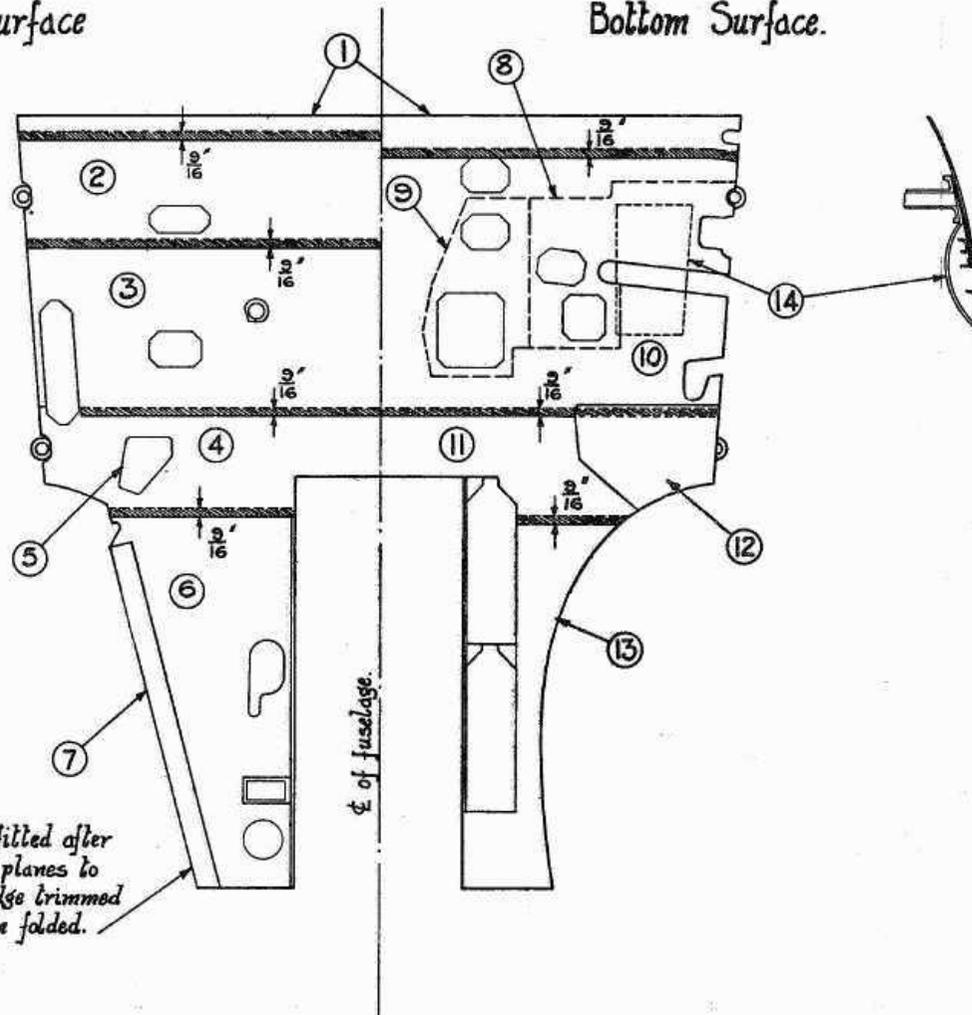
This plate to be fitted after erection of main planes to centre plane & edge trimmed to suit wing when folded.

Note:- The figures adjacent to the hatched portion show the width of lap required.

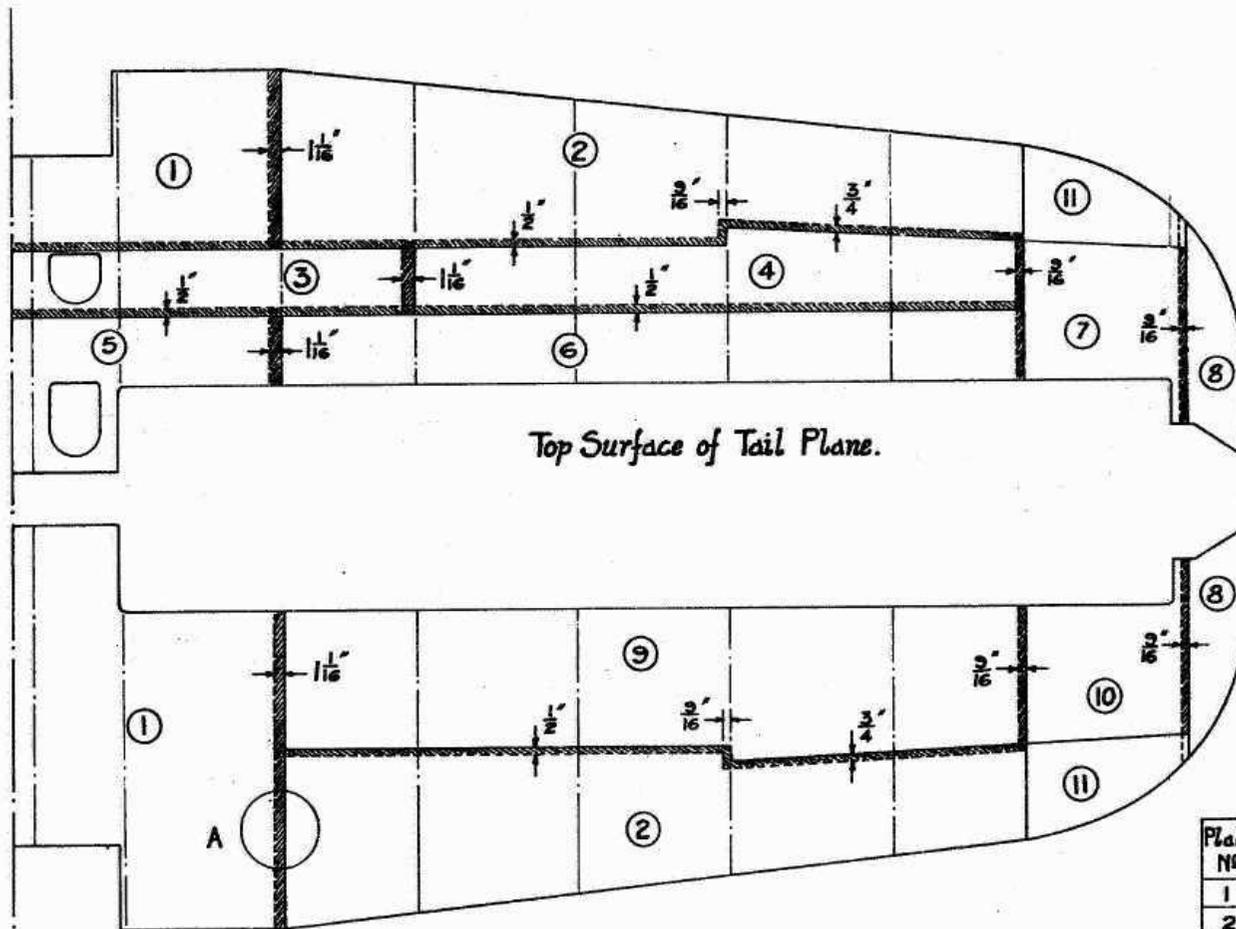
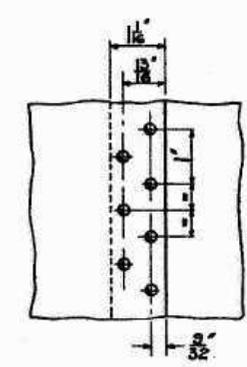
Detail A.

Note:- The figures adjacent to the hatched portion show the width of lap required.

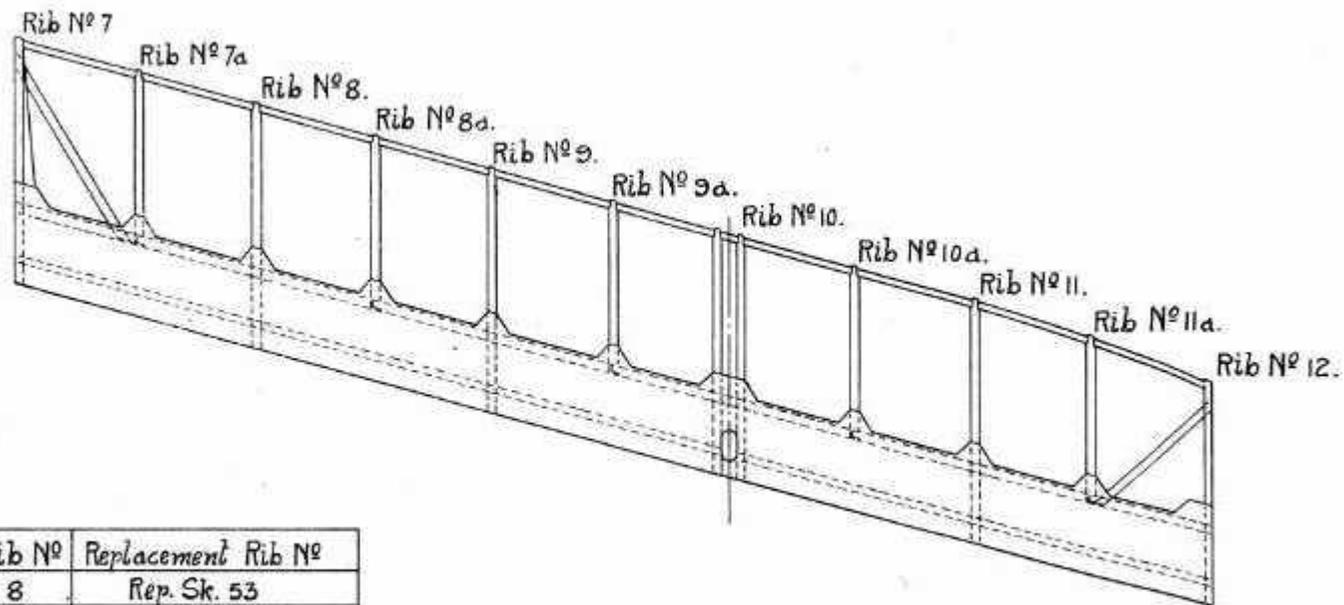
Blackburn Skua – Aileron structure.

For arrangement of replacement rib see Fig. 32
